ELECTRIC LIGHT POND DAM

NJ 00245

PHASE 1 INSPECTION REPORT NATIONAL DAM SAFETY PROGRAM

FEBRUARY 1980

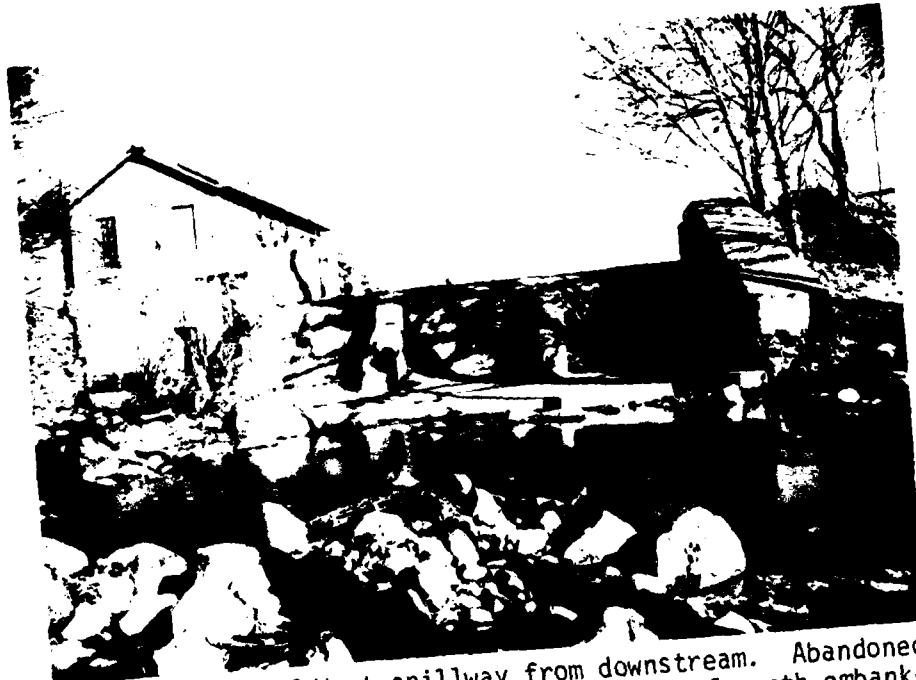
Photo 1 - View of West spillway from downstream. Abandoned power house is at left. Portion of earth embankment is at right.

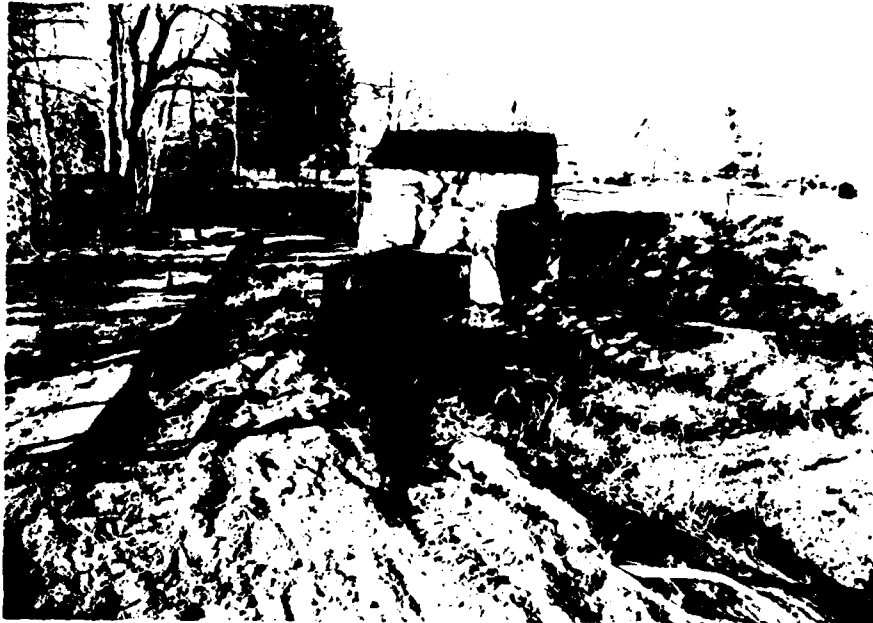
Photo 3 - View from reservoir side with dam and concrete core visible at left. The West spillway, adjacent to the abandoned power house, can be seen in center.

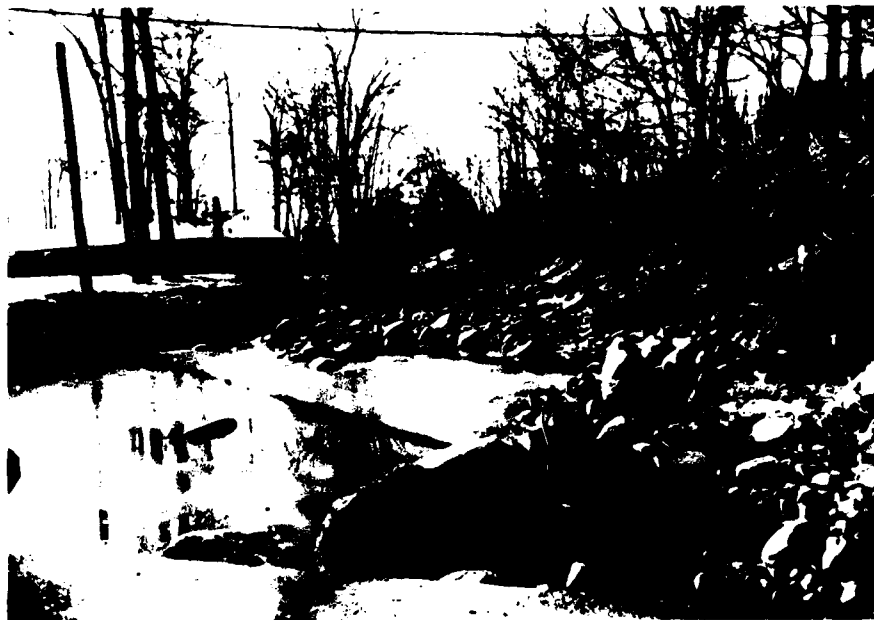
Photo 11 - View of downstream channel from West spillway
(at bottom).

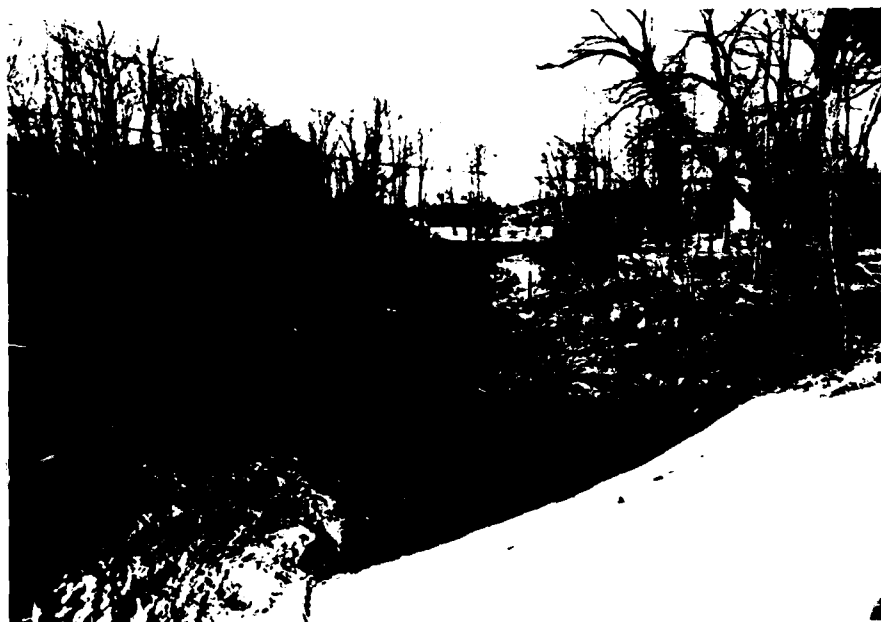
Photo 12 - View of East downstream channel. Sluice way water from
under East spillway is shown at left and portion
of emergency spillway at right.
